TECHNICAL REPORT ARLCD-TR-81016

EVALUATION OF CONTINUOUS-CAST STEEL FOR PROJECTILE BODIES

US ARMY ARMAMENT RESEARCH AND DEVELOPMENT COMMAND
LARGE CALIBER
WEAPON SYSTEMS LABORATORY
DOVER, NEW JERSEY

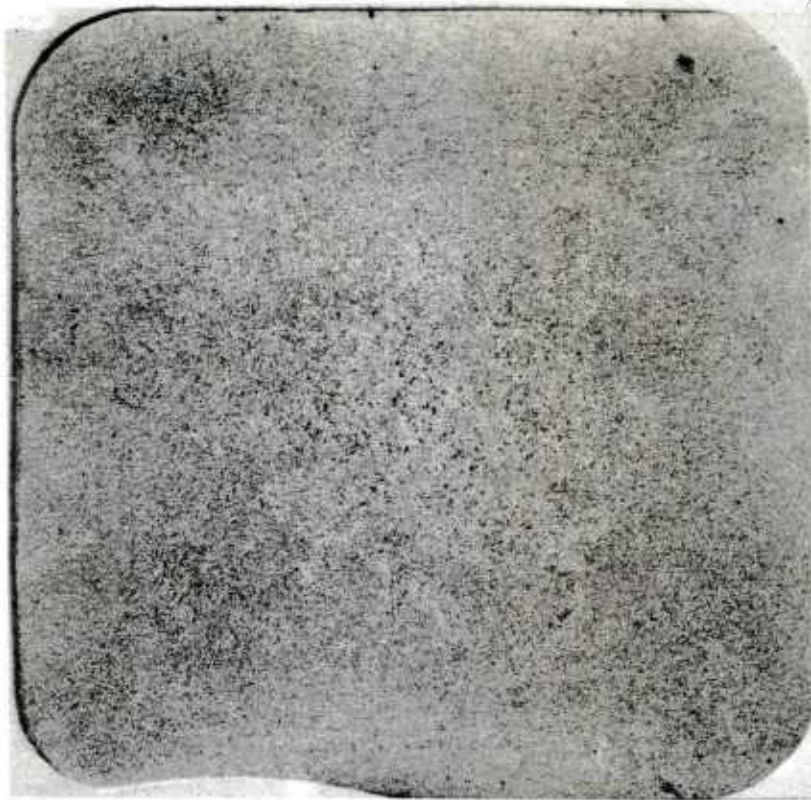
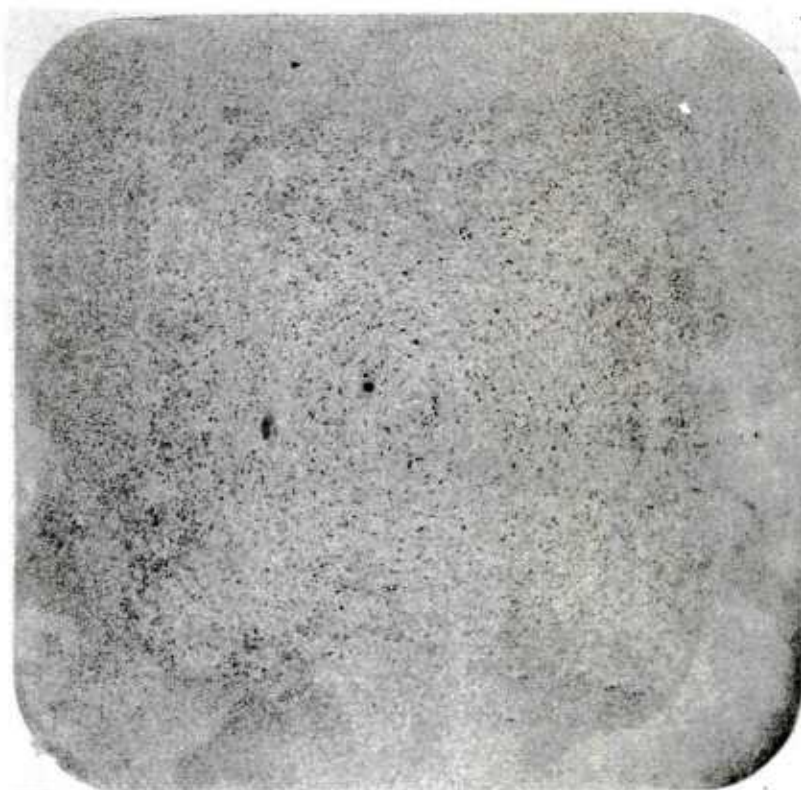
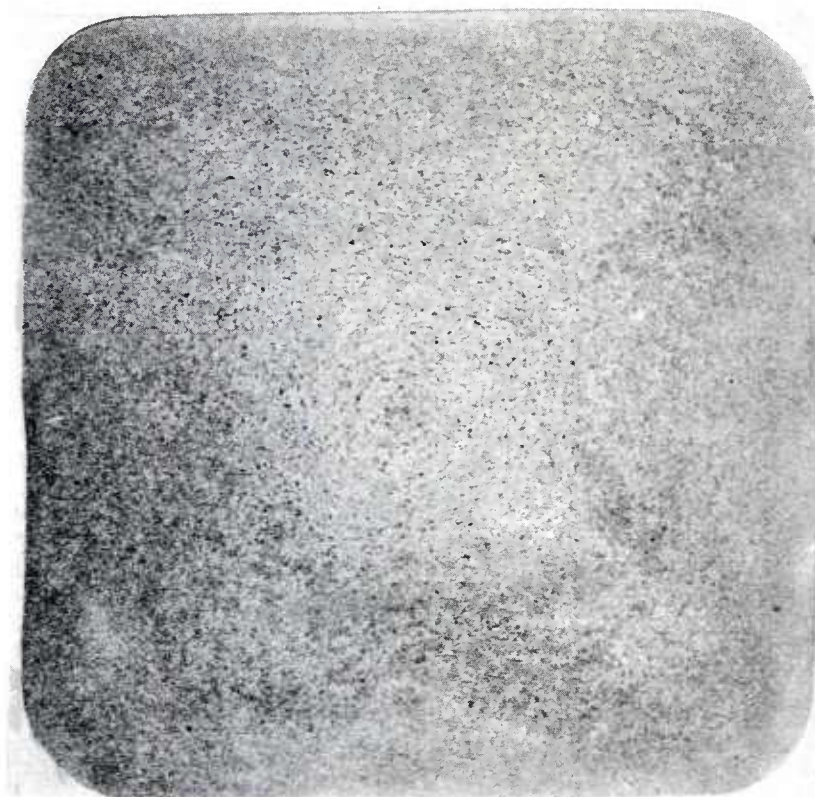
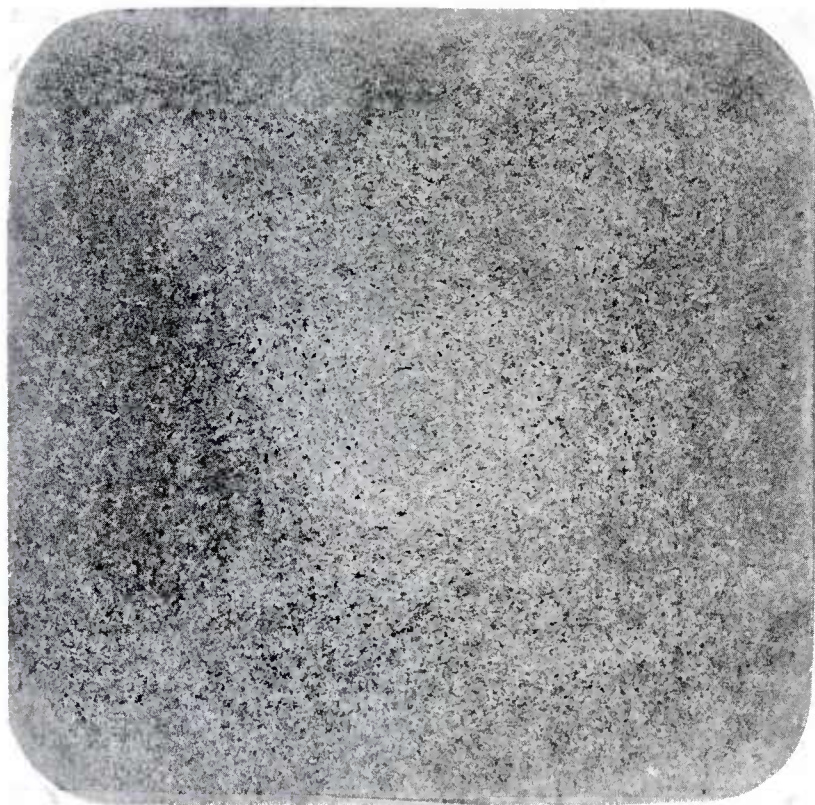
Figure 1. Macroetched bar sections - Republic Steel (1X)

Figure 1. (cont) Macroetched bar sections - Republic Steel (1X)

Macroetched sections removed from random bars of the Republic-supplied steel are shown in figure 1. These macrographs are generally equal to or better than the macroetch standards for special-quality bar steel from ingot-cast steel. Some dendritic structure is evident in the center of the macroetched sections; however, this structure is often also evident in ingot-cast steel. Aside from this dendritic structure, little segregation is evident; center soundness also appears excellent. No evidence exists of corner cracking, a defect which is common to continuous-cast steel and which occurs during solidification. However, view 1A, figure 1, shows evidence of surface conditioning. Generally, the surface finish of continuous-cast steel is superior to that of steel rolled from ingot.

The macrospecimen shown in view 1A, figure 1, was subsequently cut up for metallurgical examination. Metallographic specimens were prepared from the edge, midsection, and center of the macrospecimen. Unetched microstructures are shown in figures 2 through 4. Considerable microporosity is evident in the center of the bar. This microporosity diminishes somewhat at the midpoint between the center and edge, as shown in figure 3, and essentially disappears at the edge. This microporosity does not have any oxides or sulfides associated with it and will close up during subsequent forging operations.

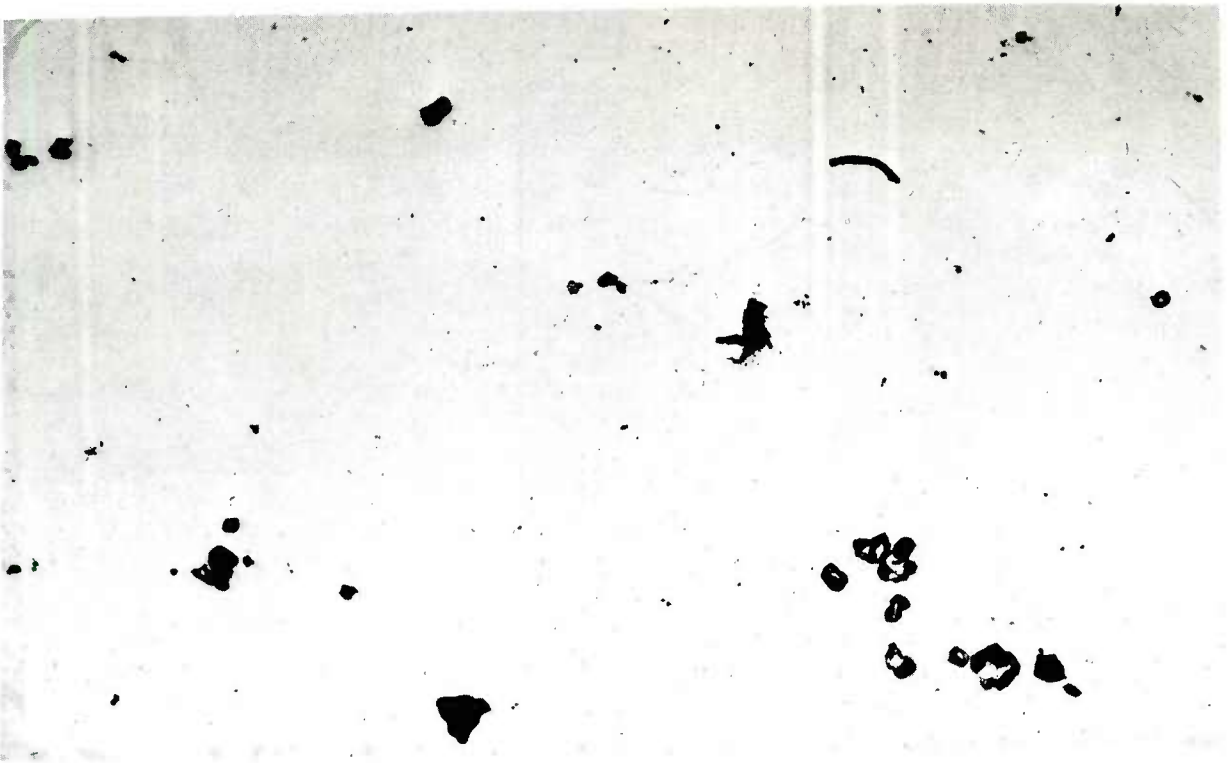
Figure 2. Microporosity at center of bar section 1A - Republic Steel (100X)

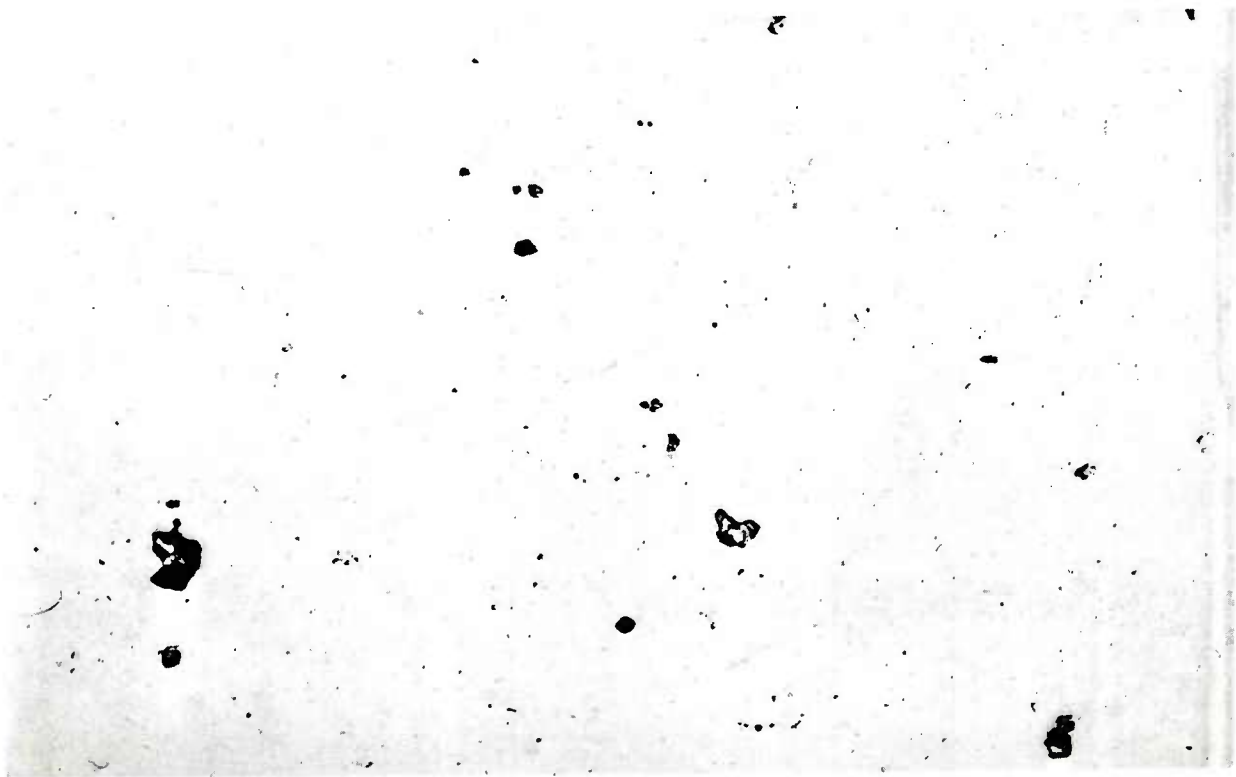
Figure 3. Microporosity midway between center and edge of bar section 1A - Republic Steel (100X)

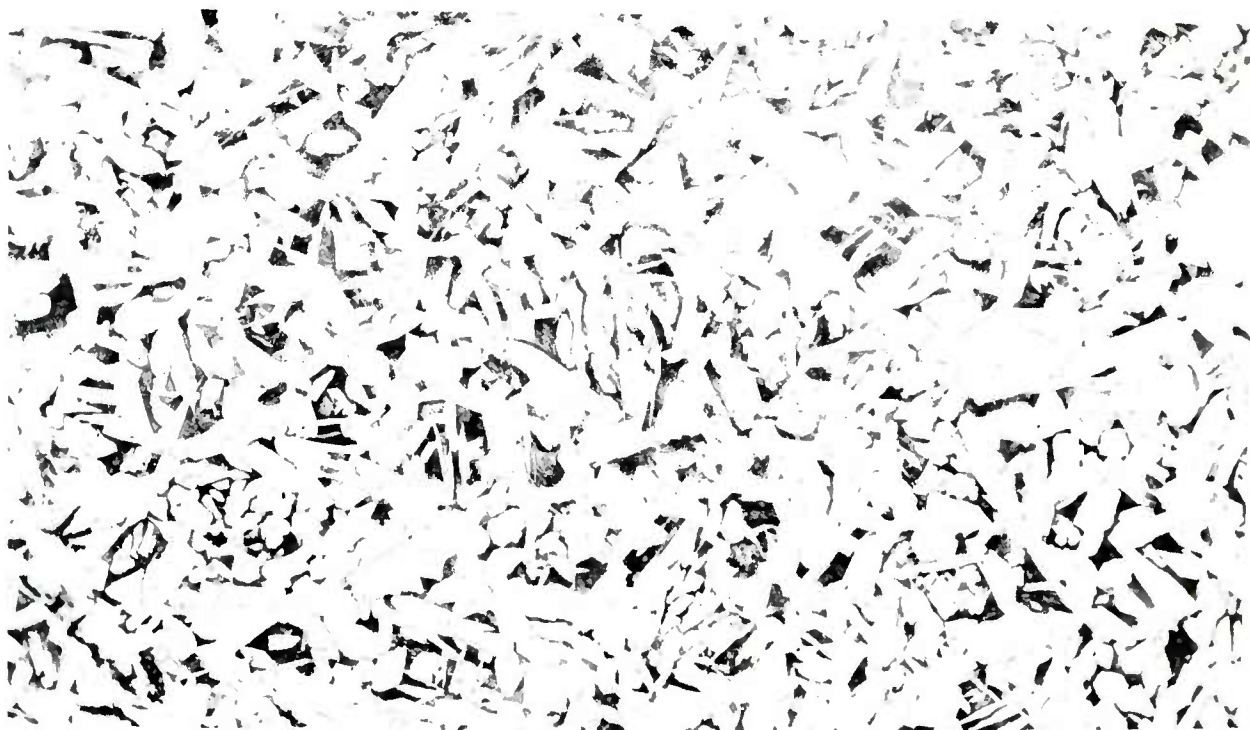
Figure 5. Microstructure at center of bar section 1A, picral etch - Republic Steel (100X)

Etched samples of the specimens depicted in figures 2 through 4 are shown in figures 5 through 7, respectively. The microstructure is shown to be very uniform from center to edge, with no evidence of microsegregation as would be apparent in an unworked continuous-cast structure. This structure is very similar to that expected in bars rolled from ingot-cast steel.

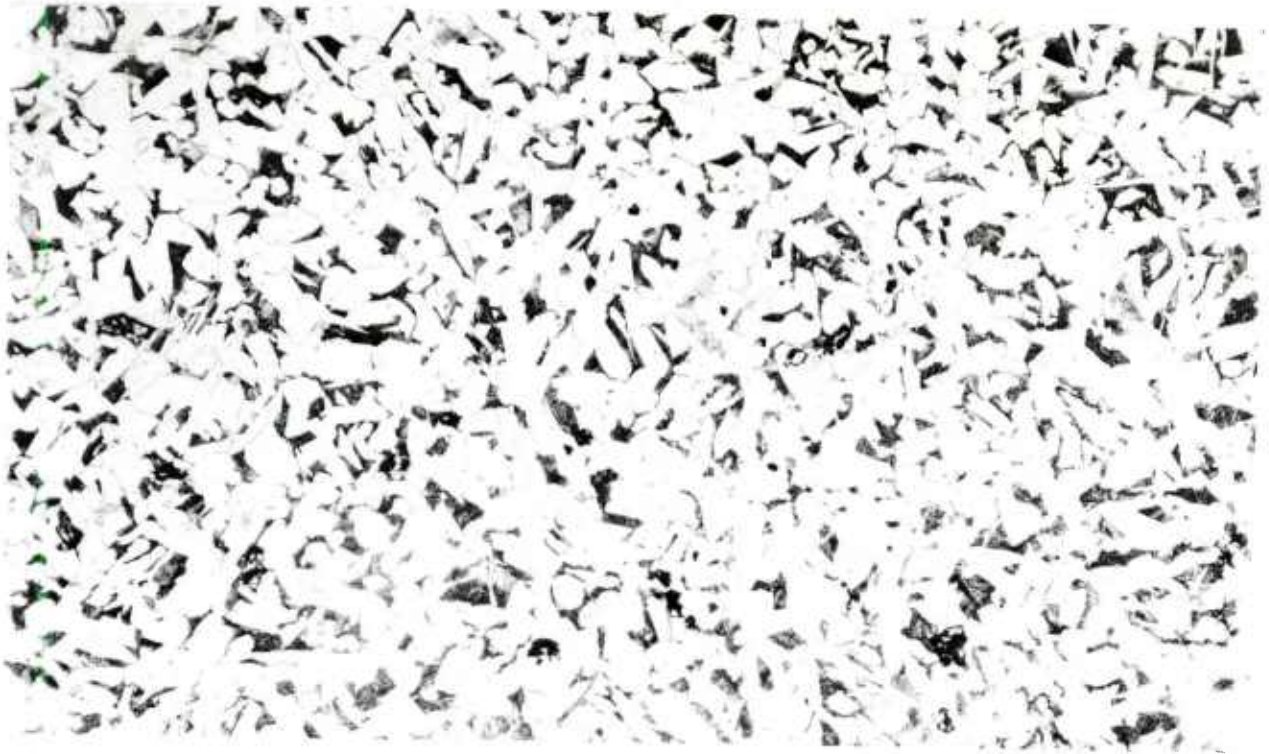
Figure 6. Microstructure midway between center and edge of bar section 1A, picral etch - Republic Steel (100X)

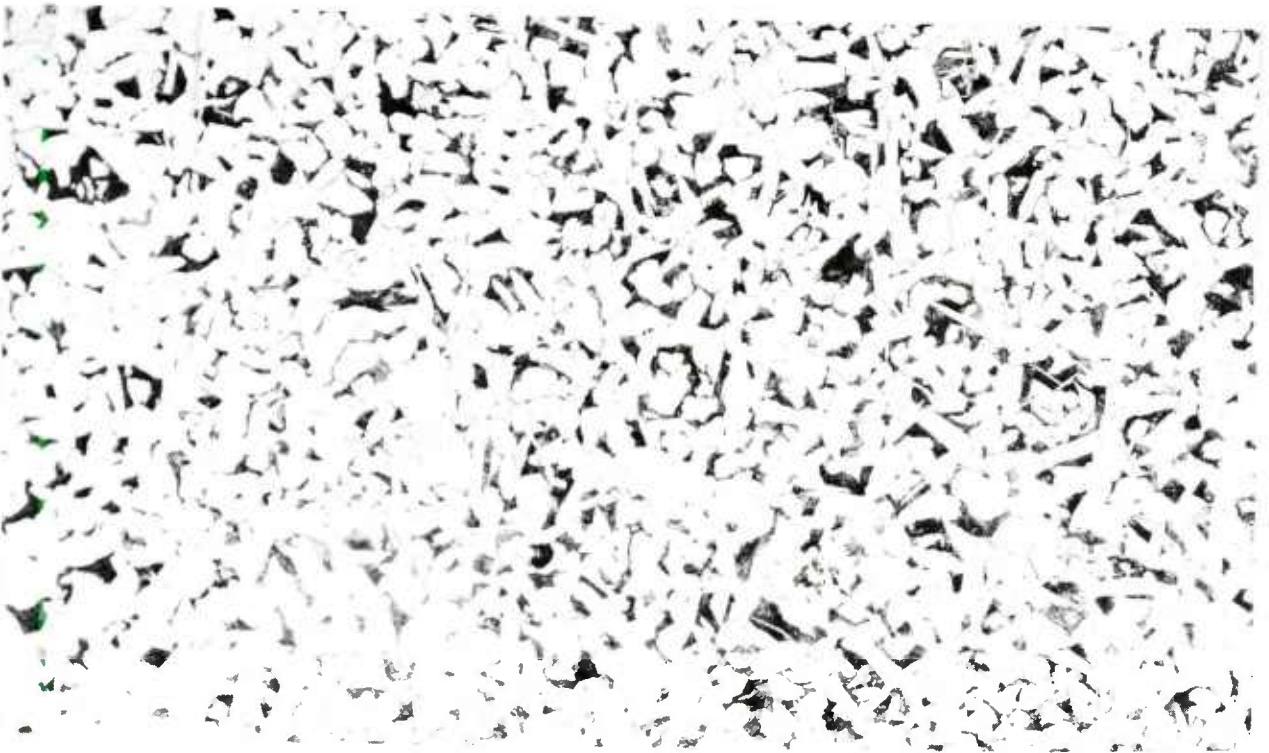
Figure 7. Microstructure at edge of bar section 1A, picral etch - Republic Steel (100X)

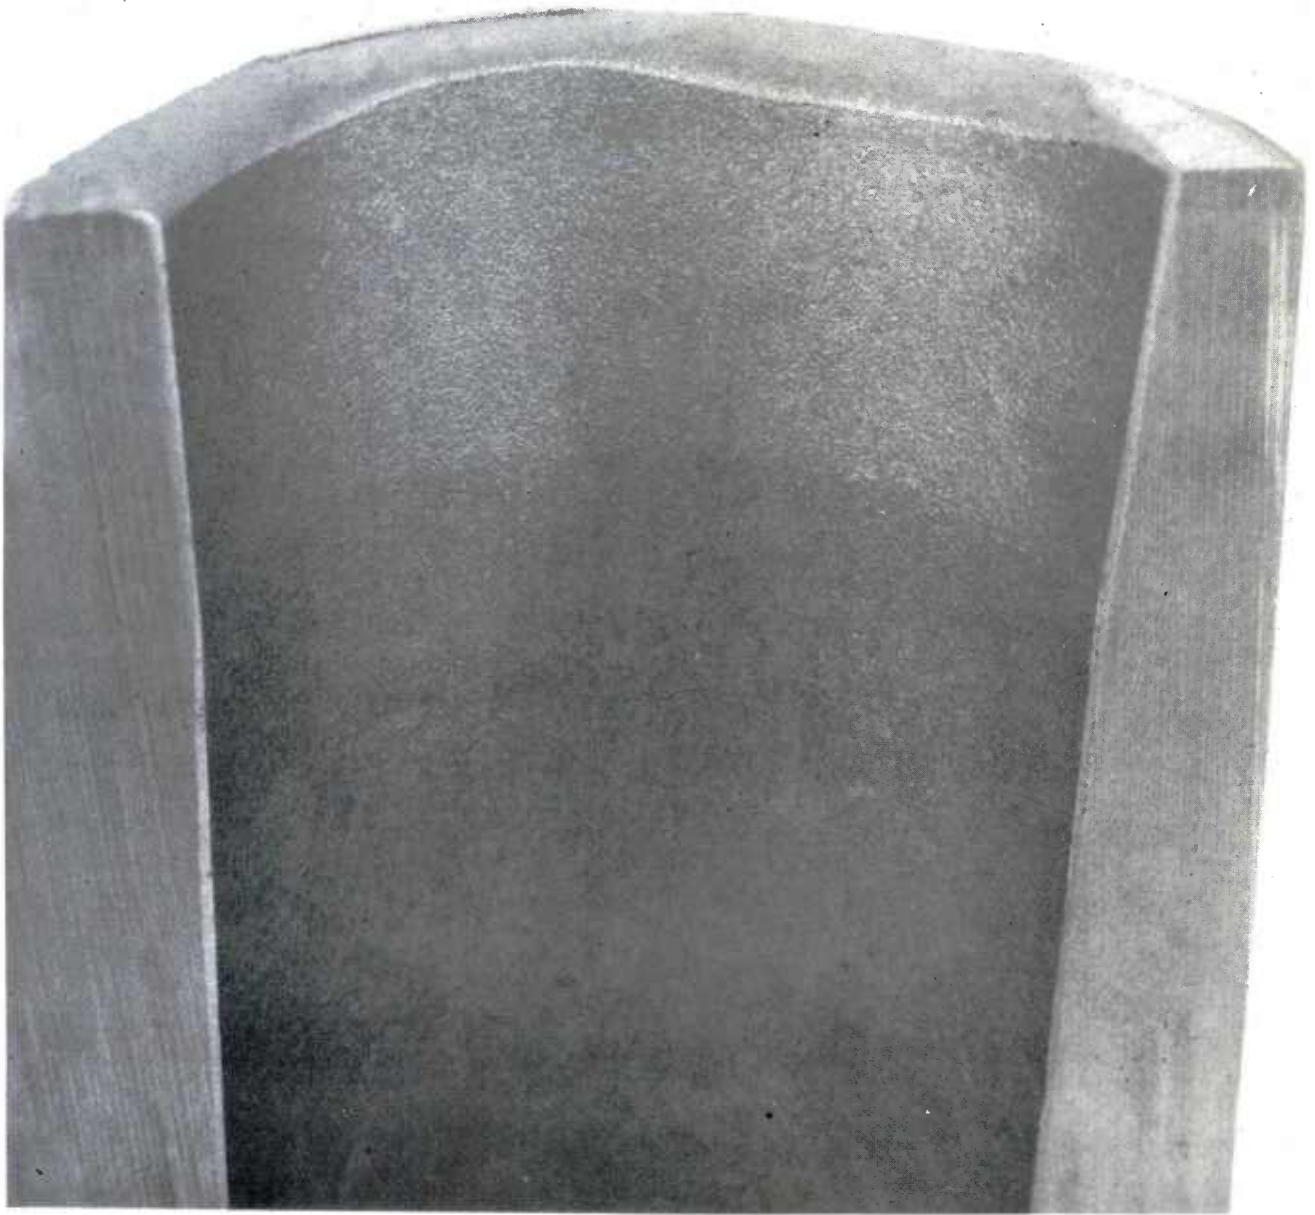
Figure 8. As-forged cavity, after shotblasting, of projectile made from Republic Steel product

Aside from the increased tonnage required in the hot forging operation, little difference was distinguished between the two steels. A portion of the cavity surface, which is excellent, is shown in figure 8. Also evident is a slight amount of earing at the open end of the forging which is normal for ingot-cast steel. No unusual defects resulted from the forging operation, and the extent of rework such as removing seams and tool marks was the same as with ingot-cast steel.

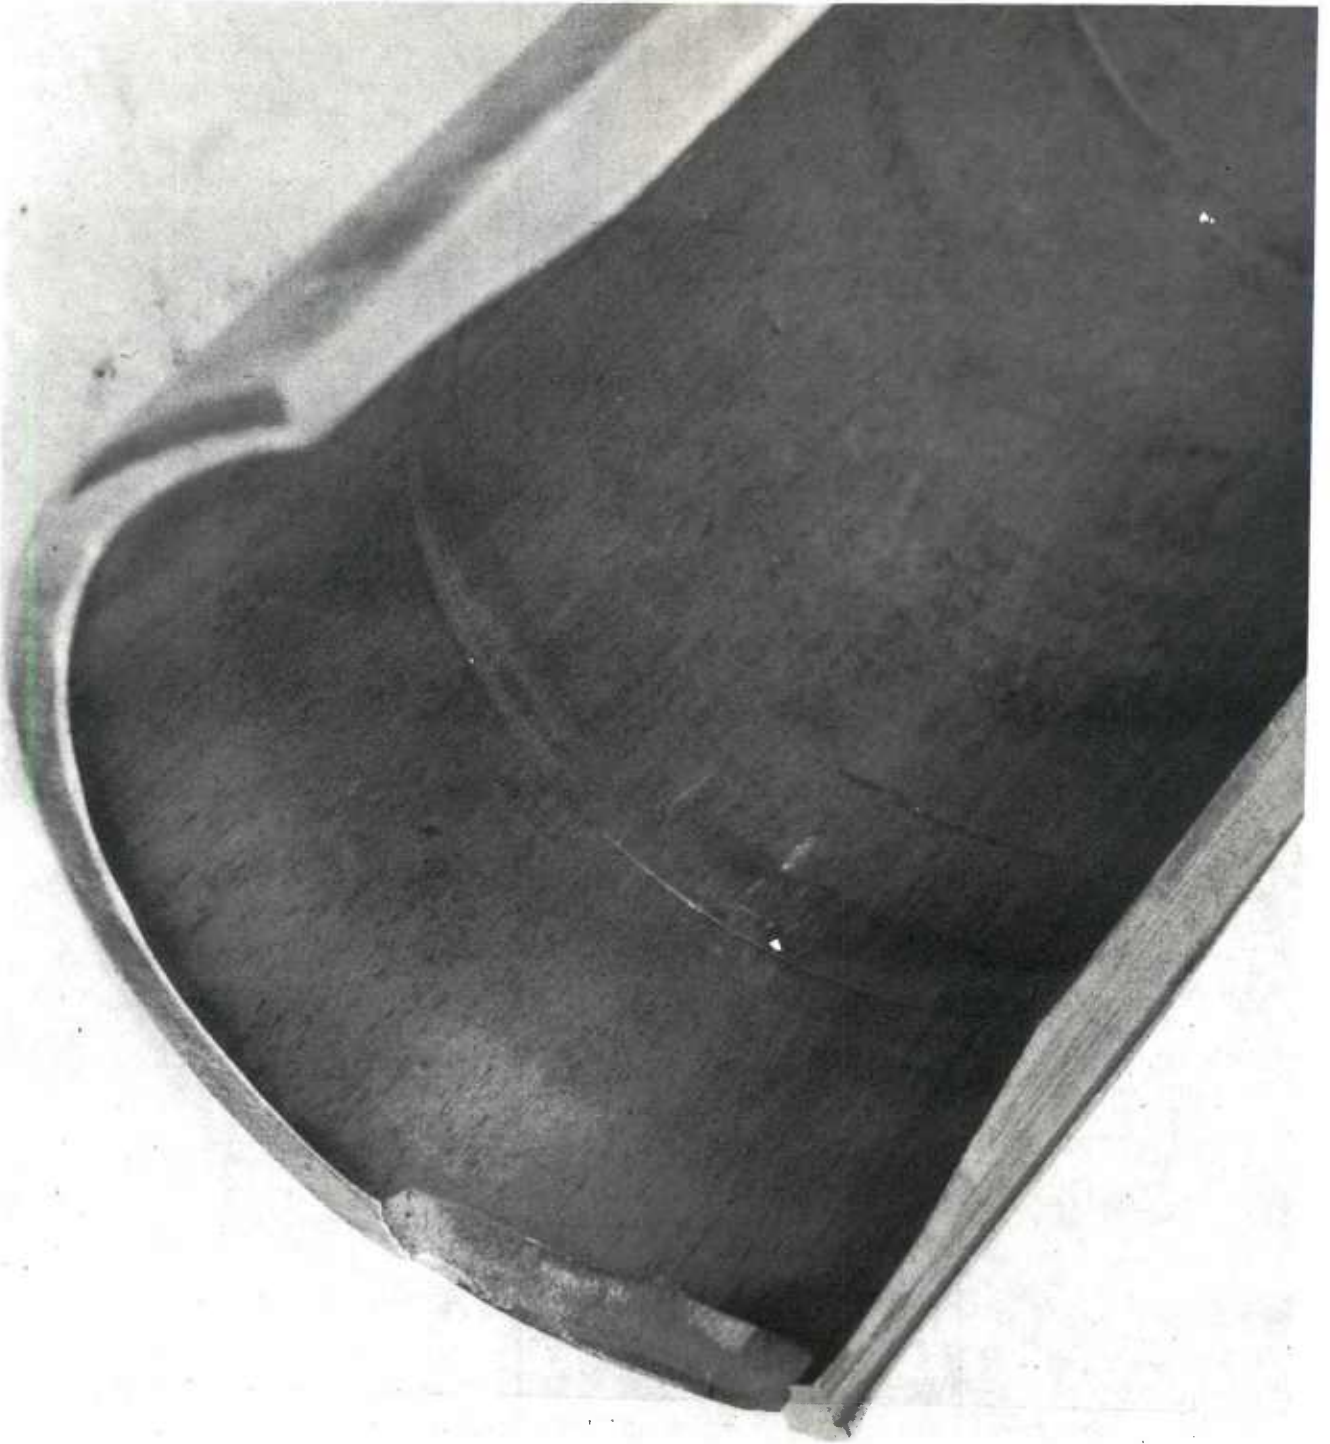
Figure 9. Example 1 of cold-drawn process piece showing breakout at open end - Republic Steel

Representative examples of chipping or breaking of the rim in the cold draw piece are shown in figures 9 and 10. A cross section of a cold drawn piece is shown in figure 9; also shown is the degree of taper formed between the punch and die at the open end. A tendency for pinching of the metal at the open end results in occasional breakage. Many of these defects were machined off during trim-to-length; however, the irregular surfaces shown in figures 9 and 10 produced the excessive tool breakage during the trimming operation. The process piece shown in figure 9 probably could not be salvaged; however, the process piece shown in figure 10 could be salvaged. Some projectile bodies which did not cleanup during trim were nosed, which usually led to the condition discussed below.

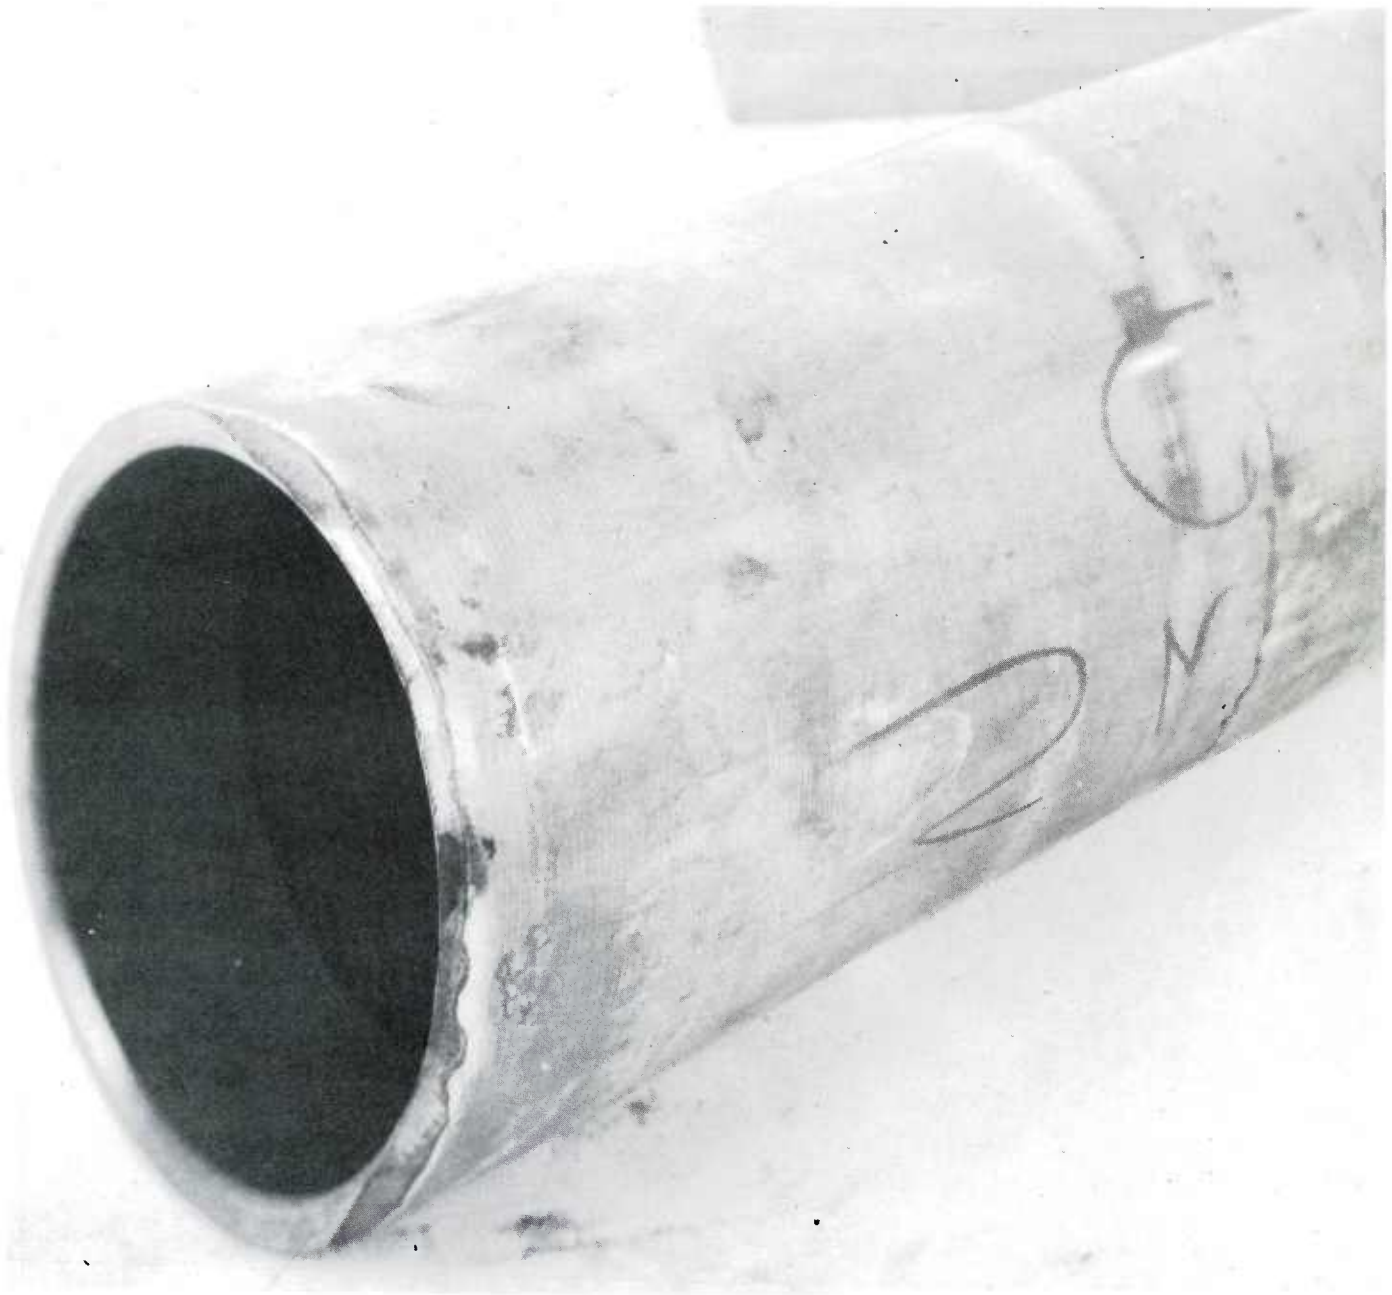
Figure 10. Example 2 of cold drawn process piece showing breakout at open end - Republic Steel

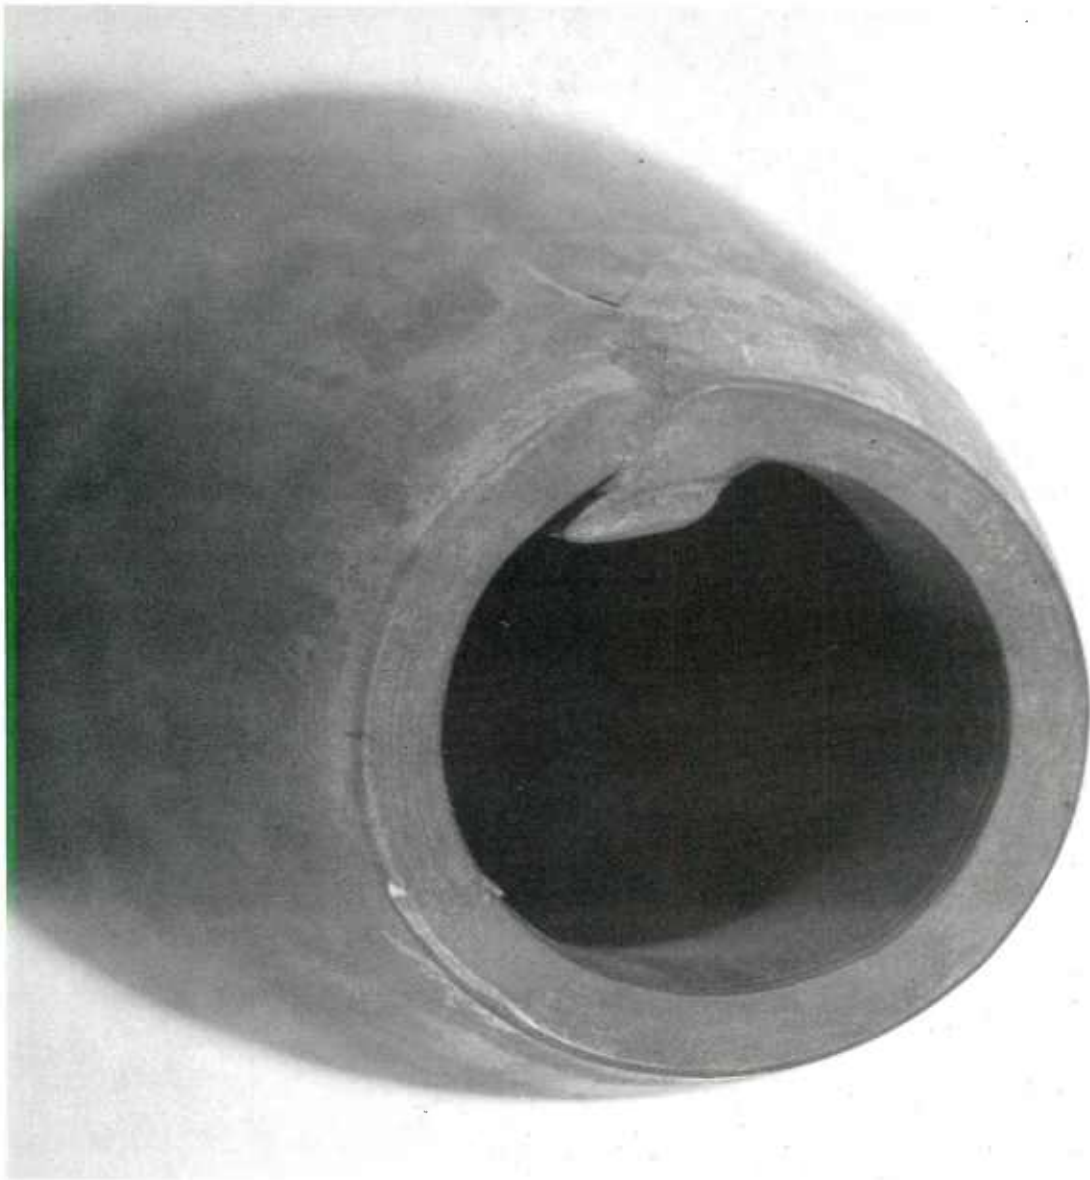
Figure 11. Example 1 of nosing defect (fold), internal view - Republic Steel

Two views each of two separate projectile bodies with nosing defects are shown in figures 11 through 14. The projectile body shown in figures 11 and 12 has sheared through the wall during nosing, displacing steel to the inside and producing cracks farther down the nose. These cracks are more evident in figure 12.

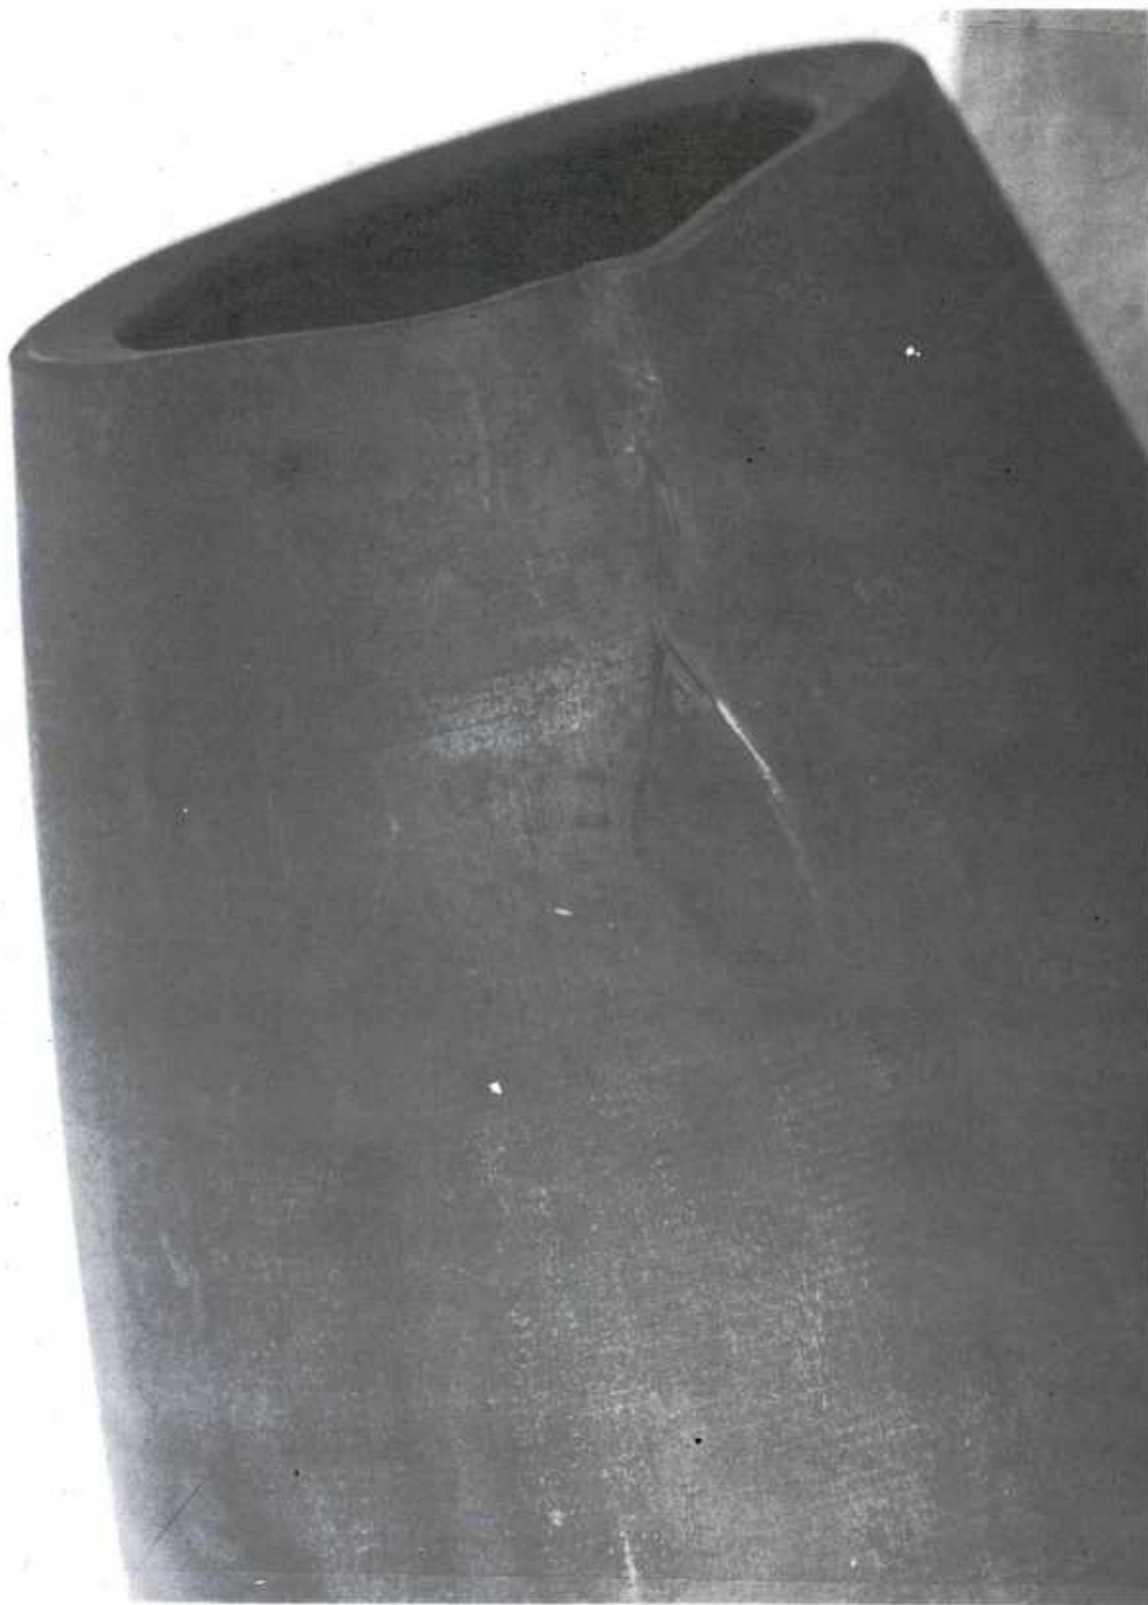
Figure 12. Example 1 of nosing defect (fold), external view - Republic Steel

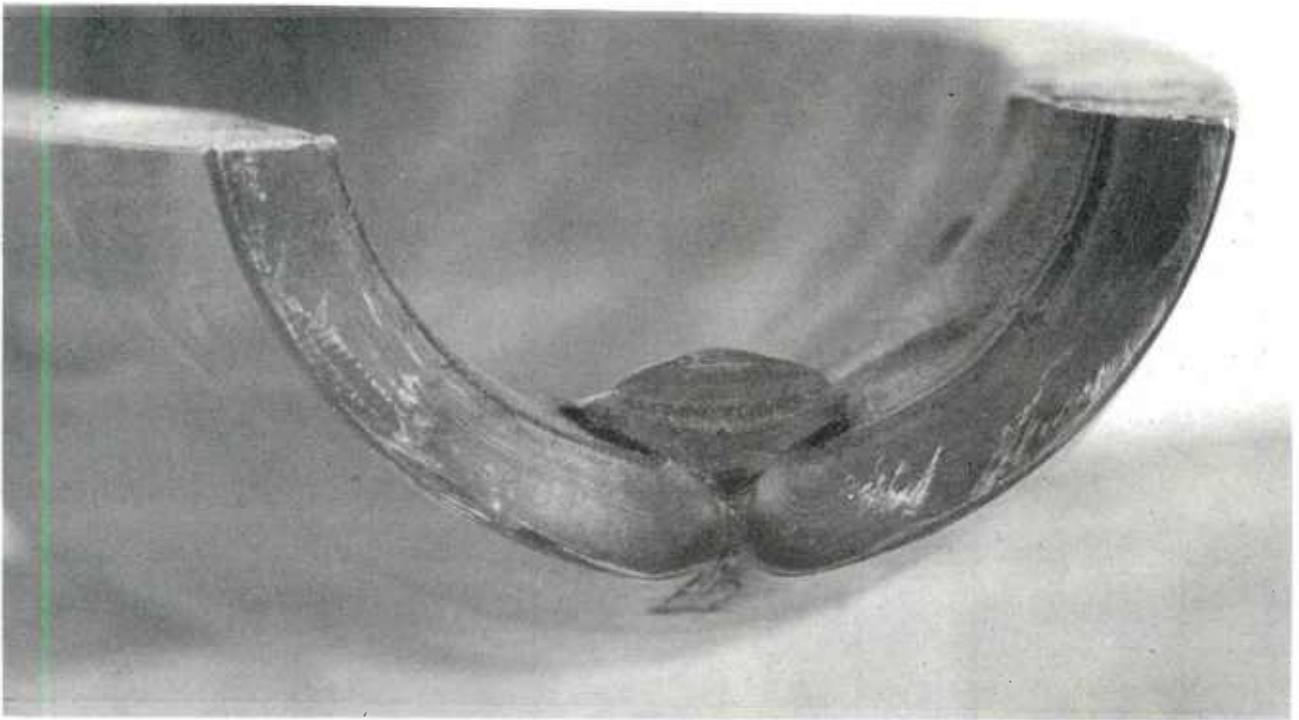
Figure 13. Example 2 of nosing defect (fold), internal view - Republic Steel

The projectile body shown in figures 13 and 14 folded inward during nosing, also displacing steel to the inside, which is more evident in figure 13. This defect does occur in regular production with ingot-cast steel and is not believed to be in any way associated with the material properties of continuous-cast steel. Projectile bodies with defects like those depicted in figures 11 through 14 cannot be salvaged. However, some projectile bodies with less severe defects were salvaged.

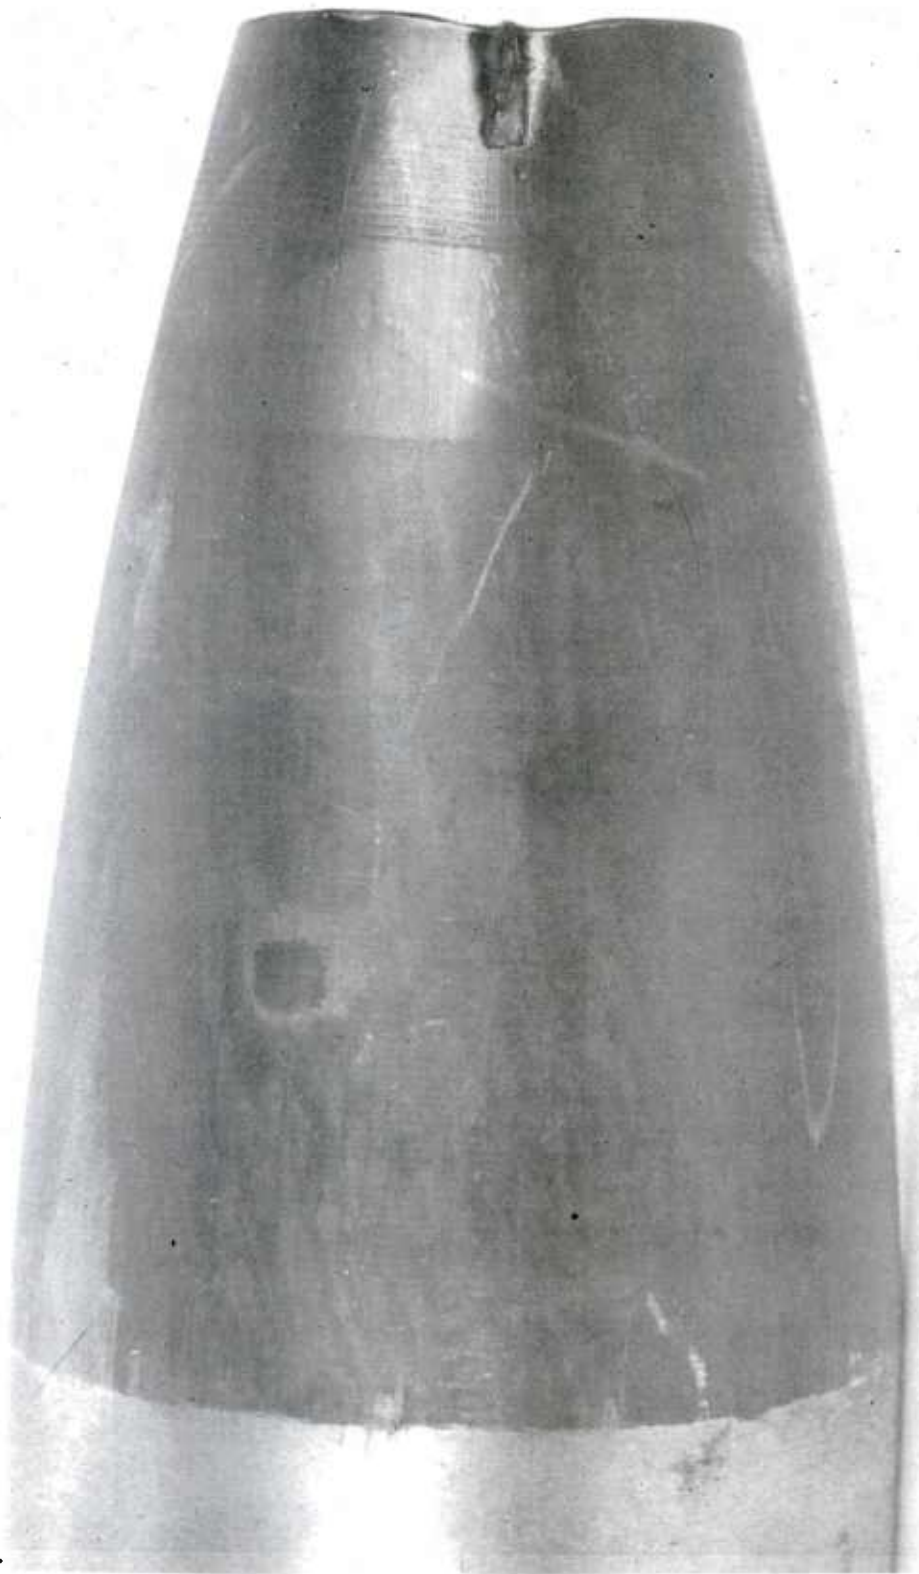
Figure 14. Example 2 of nosing defect (fold), external view - Republic Steel

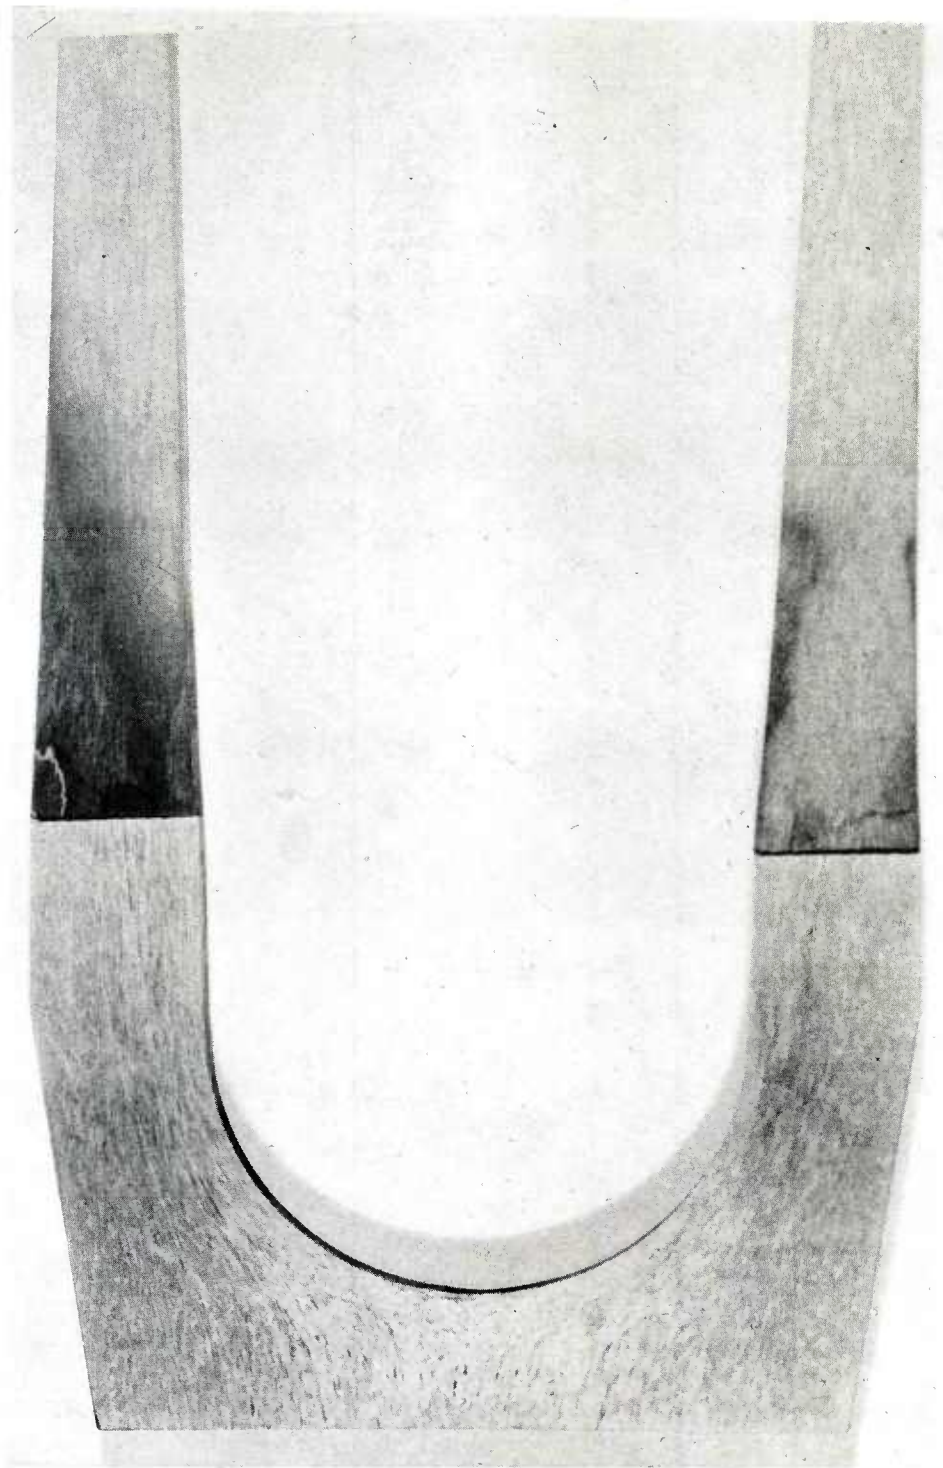
Figure 15. Example 1 of macroetched base section of projectile made from Republic Steel product

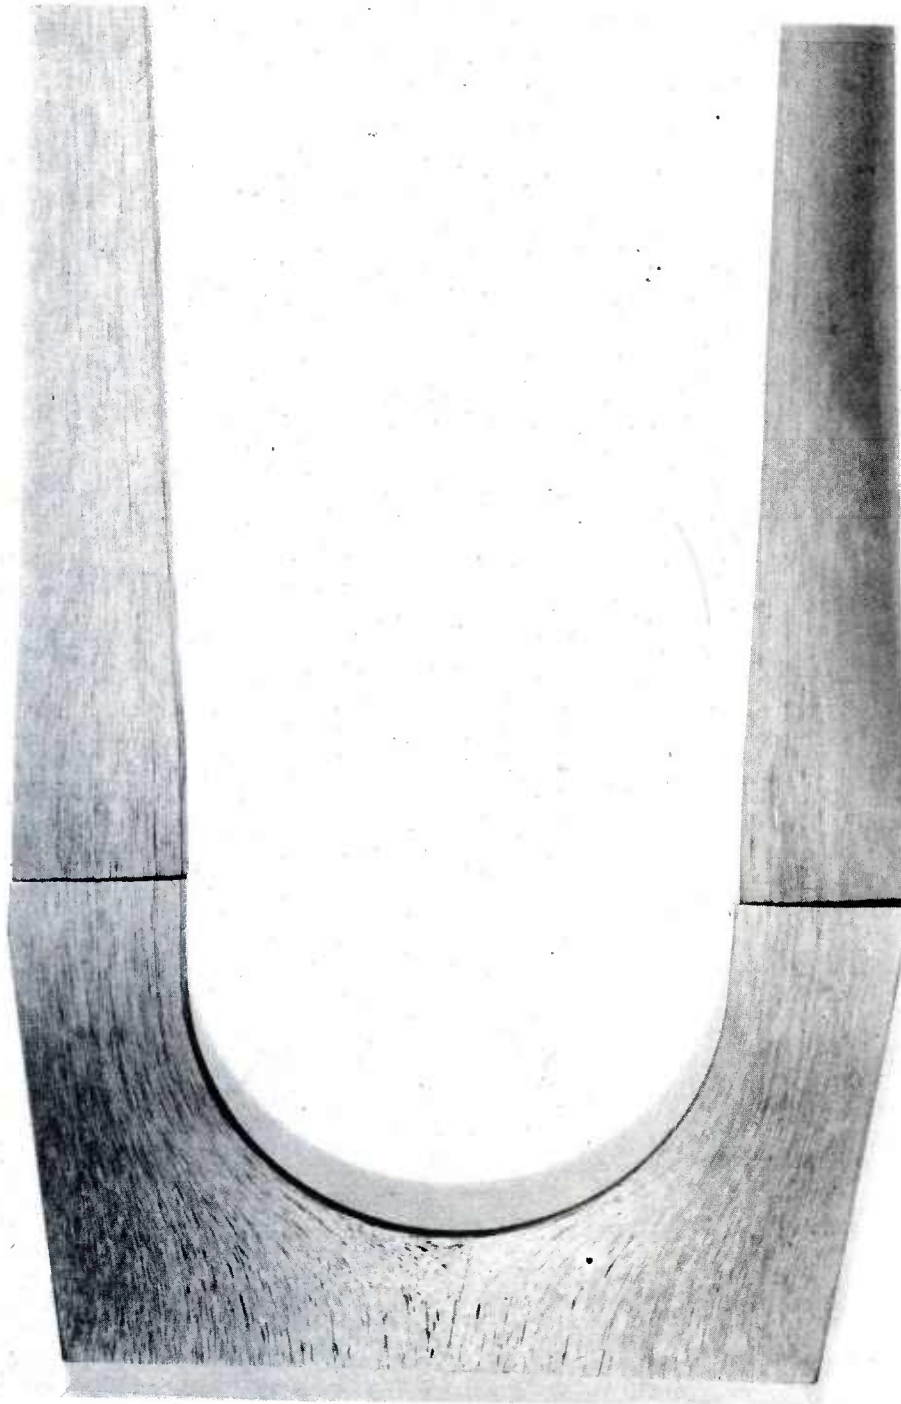
Figure 16. Example 2 of macroetched base section of projectile made from Republic Steel product
